DEPARTMENT OF TRANSPORTATION**DIVISION OF ENGINEERING SERVICES**

Contract #: 04-0120F4Cty: SF/ALA Rte: 80 PM: 13.2/13.9File #: 1.28**WELDING INSPECTION REPORT****Resident Engineer:** Siegenthaler, Peter**Address:** 333 Burma Road**City:** Oakland, CA 94607**Report No:** WIR-019474**Date Inspected:** 24-Jan-2011**Project Name:** SAS Superstructure**OSM Arrival Time:** 1000**Prime Contractor:** American Bridge/Fluor Enterprises, a JV**OSM Departure Time:** 1830**Contractor:** American Bridge/Fluor Enterprises, a JV**Location:** Job Site

WELDING INSPECTION REPORT

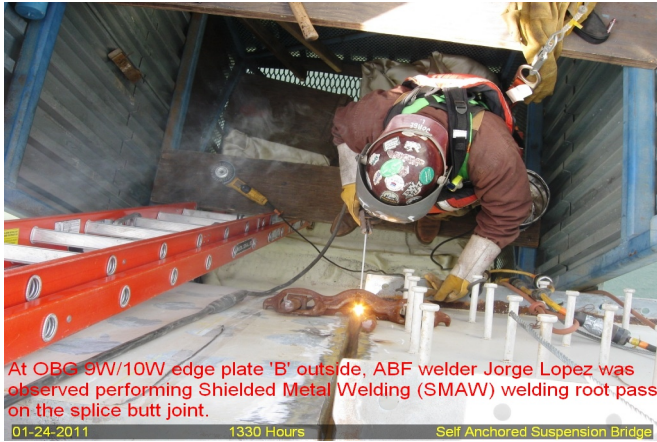
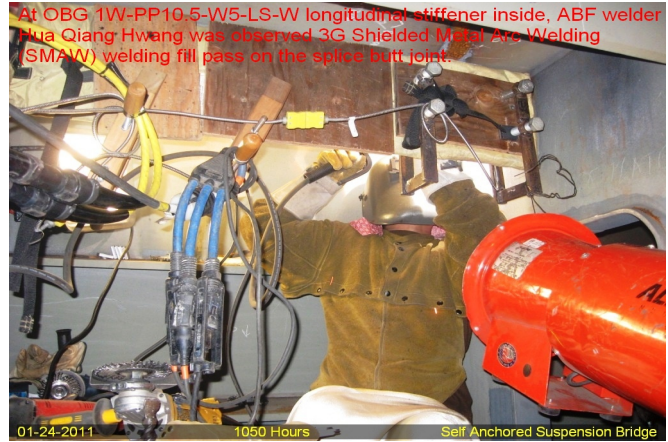
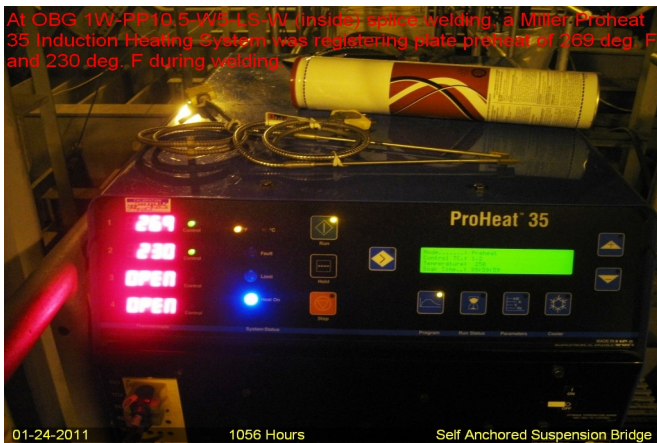
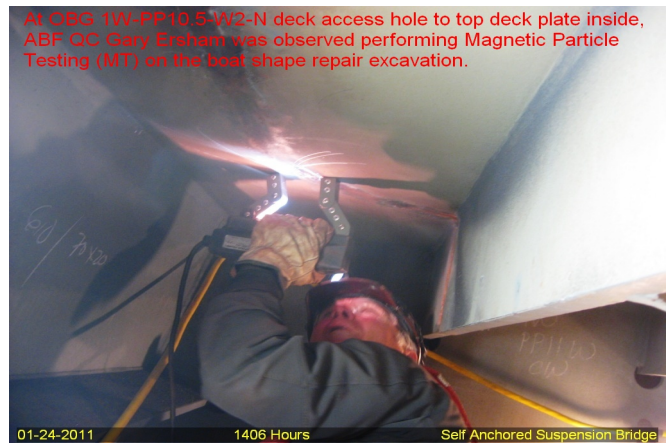
At OBG 1W-PP10.5-W5-LS-W longitudinal stiffener inside, QA randomly observed ABF welder Hua Qiang Hwang perform 3G (vertical) Shielded Metal Arc Welding (SMAW) complete joint penetration (CJP) welding fill pass to cover pass on the stiffener splice butt joint. The stiffener plates being welded are made of high strength plate material HPS 485W and has a thickness of 30mm. The joint has a double V joint preparation that was welded from one side and after the completion from one side it was back gouged and Non Destructive Testing (NDT) tested using Magnetic Particle Testing (MT) and back welded to the other side. Prior welding, the fit up was inspected and accepted by ABF QC Gary Ersham. QA Danny Reyes also verified the fit up alignment. The welder was noted using E9018H4R with 1/8" diameter electrode implementing Caltrans approved welding procedure specification (WPS) ABF-WPS-D1.5-1012-3. The joint being welded was root welded using a ceramic backing. The splice joint was preheated to greater than 200 degrees Fahrenheit using Miller Proheat 35 Induction Heating System heater blanket located at the opposite side of the plate prior/during welding. The QA Inspector noted the ABF QC Gary Ersham was on site monitoring the in process preheats and welding parameters. During the shift, QA noted ABF QC was closely monitoring the issuance of E9018H4R electrodes due to its limited exposure time allowed. At the end of the shift, cover pass welding on both sides of the joint was completed.

At OBG 9W/10W edge plate 'B' outside, QA randomly observed ABF/JV qualified welder Jorge Lopez perform root pass welding on the CJP splice butt joint. The welder was observed manually welding in the 3G (vertical)

position utilizing a SMAW with 1/8" diameter E7018H4R electrode and implementing Caltrans approved Welding Procedure Specification (WPS) ABF-WPS-D15-1040B. The joint being welded has a single V-groove butt joint with copper backing bar. Prior welding, QA has noted ABF QC William Sherwood verifying the fit up alignment of the joint. According to QC, the alignment mismatch measured was 2.0mm or less. QA performed random verification on the mismatch measurement and came up same results. During welding, ABF Quality Control (QC) William Sherwood was noted monitoring the welding parameters of the welder. QA randomly monitored the welding parameter with reading of 130 amperes which appears in conformance to the contract requirements. At the end of the shift, SMAW root pass welding was still continuing and should remain tomorrow.

At OBG 1W-PP10.5-W2-N deck access hole to top deck plate inside, QA randomly observed ABF/JV qualified welder Jin Pei Wang perform CJP repair welding. The welder was noted welding in 4G (overhead) position utilizing SMAW with 1/8" diameter E7018H4R electrode implementing Caltrans approved Welding Procedure Specification (WPS) ABF-WPS-D15-1001 Repairs. The welding repairs were excavated to a boat shape profile and were tested with Magnetic Particle Testing (MT) prior welding. During welding, ABF QC Gary Ersham was noted monitoring the welder and his welding parameters. The locations of the repairs were noted below;

At the request of Quality Control Field Supervisor, Bonifacio Daquinag, QA has randomly verified the QC visual inspection of the CJP welding of the following Lifting Lug Holes (LLH); The QA verification was performed to verify that the welding and the visual weld inspection performed by the QC inspector meet the requirements of the contract documents. At the conclusion of the QA verification it appeared that the welds and the QC inspection complies with the contract documents.
